Device **TC22x/TC21x**
Marking/Step **ES-AC, AC**
Package **see Data Sheet**

10208AERRA

This Errata Sheet describes the deviations from the current user documentation.

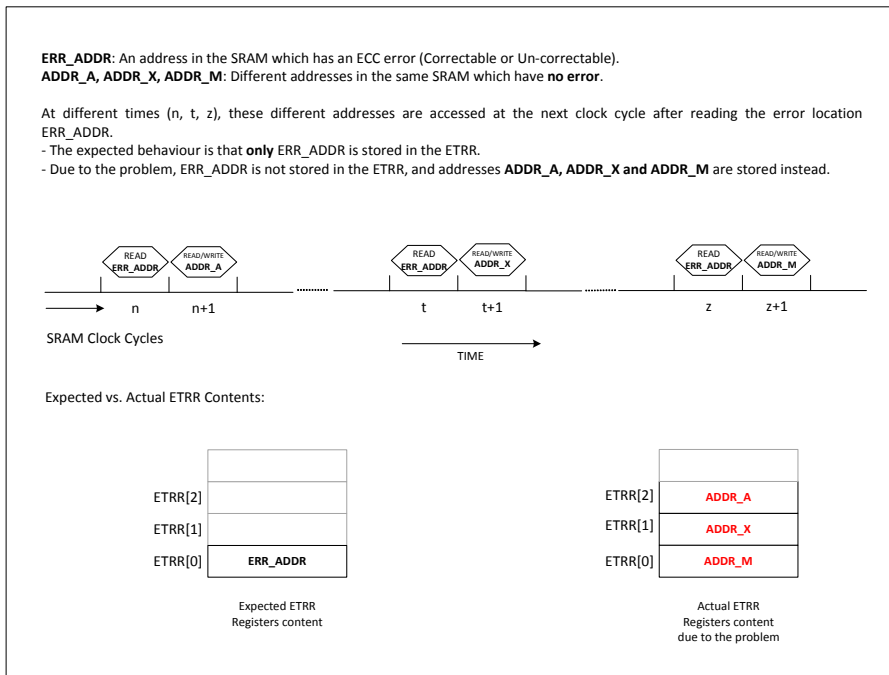
Figure 1 Example sequence showing how registers ETRRx may be filled with “Error Free” addresses

When such a consecutive access sequence (read from ERR_ADDR followed by read/write of different address(es)) happens multiple times, registers ETRRx

are filled with addresses that have actually no error – and the SRAM address which actually has an error is not stored indeed. **Figure 1** shows such an example scenario.

The consequence of the scenario explained in **Figure 1** is that a single error in the SRAM – example just one correctable error at a location ERR_ADDR – can result in registers ETRRx getting filled with fault-free address, and thus potentially even triggering an ETRR overflow.

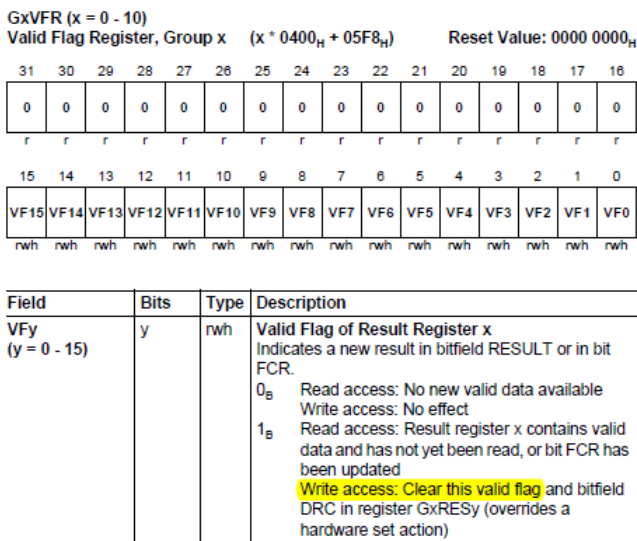
Figure 3 Register GxVFR in the VADC Module of TC2xx Devices

Note: Writing a different value (e.g. writing a 1_B to a bit currently at 0_B) is not affected, and works as expected to modify only the selected bit.

The bits in the GxVFR register have to be written with 1_B to clear a valid flag VFy indicating a valid result. Assuming VFy = 1_B, if one of the RMW instructions listed above is used, the write to VFy would never happen since VFy is already set to 1_B. This means that the next read of VFy may lead to incorrect conclusions by software.

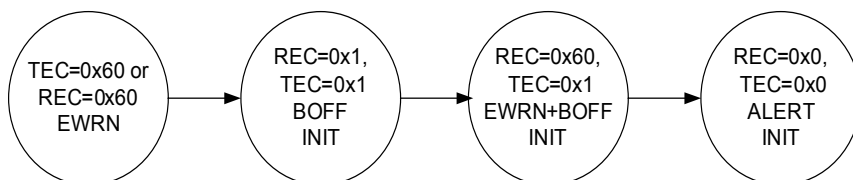
Figure 4 Alert Interrupt Behavior in case of Bus-Off

MultiCAN_AI.H007 Alert Interrupt Behavior in case of Bus-Off

When the threshold for error warning (EWRN) is reached (default value of Error Warning Level EWRN = 0x60), then the EWRN interrupt is issued. The bus-off (BOFF) status is reached if $TEC > 255$ according to CAN specification, changing the MultiCAN module with REC and TEC to the same value 0x1, setting the INIT bit to 1_B, and issuing the BOFF interrupt. The bus-off recovery phase starts automatically. Every time an idle time is seen, REC is incremented. If REC = 0x60, a combined status EWRN+BOFF is reached. The corresponding interrupt can also be seen as a pre-warning interrupt, that the bus-off recovery

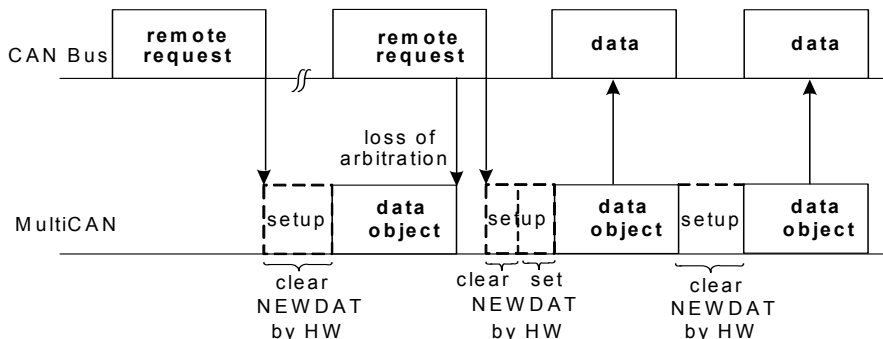
Figure 5 Loss of Arbitration

When the appropriate message object (data frame) triggered by the first remote frame wins the arbitration, it will be sent out and NEWDAT is not reset. This leads to an additional data frame, that will be sent by this message object (clearing NEWDAT).

There will, however, not be more data frames than there are corresponding remote requests.

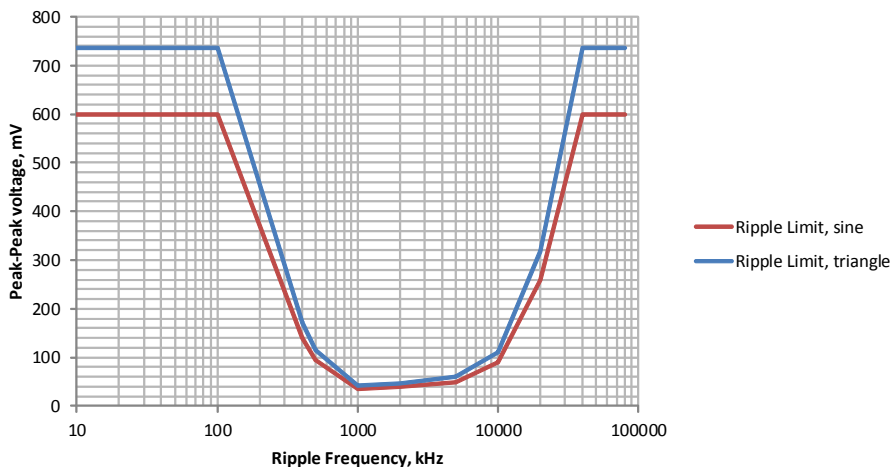
Figure 8 Ripple Voltage vs. Frequency Characteristic

improper behavior of the start-up scheme of the back-up clock, and thus stuck-at state during the start-up of the microcontroller until this condition is removed.

The diagram reflects acceptable ripple level during the cold start of the microcontroller at the respective VDDP3/VEXT/VEVRSB supply of the PMS subsystem, depending on the device and package type, as shown in the following table.

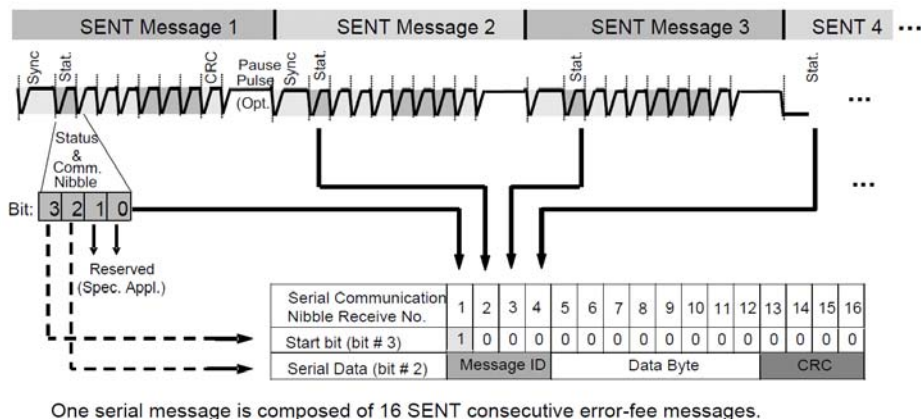
Figure 9 Short Serial Message, Serial Data Encoding over 16 messages

Figure 9 shows a corrected version of this figure.
